AN INVESTIGATION OF THE INITIATION
STAGE OF HOT CORROSION IN NI-BASE
ALLOYS

Second Semi-Annual Report

on
Grant No. NSG-3214

T. T. Huang
G. H. Meier

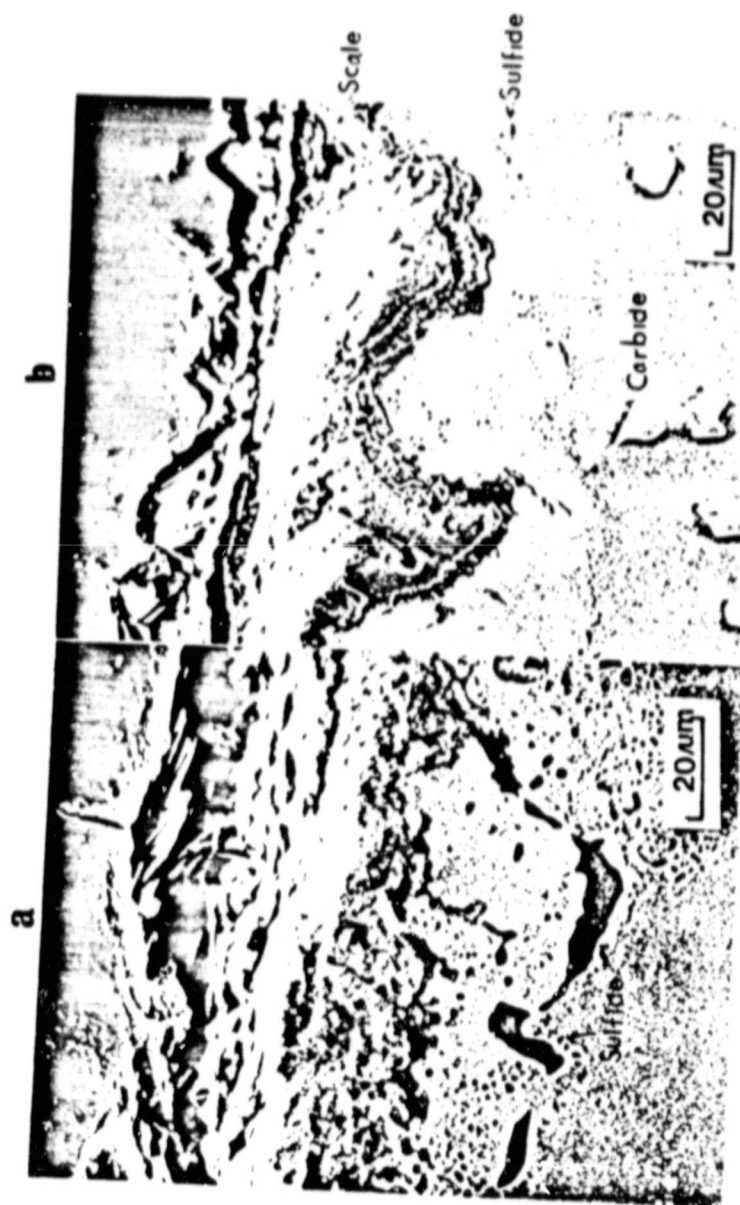
Figure 7. IN-738 coated with $1 \text{ mg/cm}^2 \text{ Na}_2\text{SO}_4$ and oxidized at 970°C for 10 hours

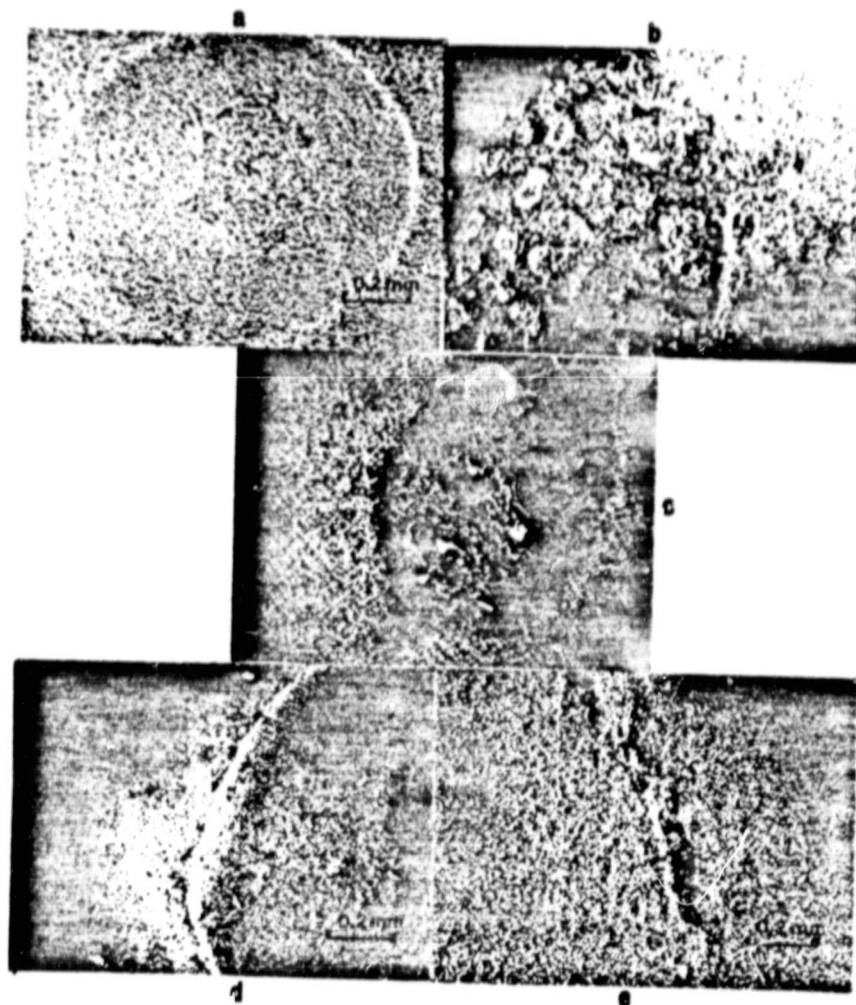
Figure 9. Remelted IN-738 coated with $1 \text{ mg/cm}^2 \text{ Na}_2\text{SO}_4$, oxidized at 970°C for
(a) 10 min. (b) 60 min. (c) 60 min. (d) 30 min. (e) 120 min.

Figure 9 (a)-(e) shows the surface of the remelted IN-738, which was coated with Na_2SO_4 and oxidized at 970°C for various times. It is clear the carbides dissolve into the molten salt immediately. The attack of the surface is visible in some areas. More detail of some of these regions is shown in Figure 10. Figure 10 (a) shows the region, where large TiO_2 crystals form on the surface of a layer of Cr_2O_3 . In the right side of this picture some Al_2O_3 whiskers have grown on the surface while on the left side no Al_2O_3 is found. The transition from an Al_2O_3 whisker-rich region to a whisker-free region is shown in Figure 10 (b) and more detail of these two regions is shown in Figure 10 (c) and (d). One important difference is that in the whisker-rich region large plates of TiO_2 grow along with Al_2O_3 whiskers on top of a finer-grained Cr_2O_3 layer, while in the whisker-free regions the density and the size of these TiO_2 crystals is greatly reduced. The mechanism of growth of these Al_2O_3 whisker is not clear, but apparently they can be dissolved into the molten salt.

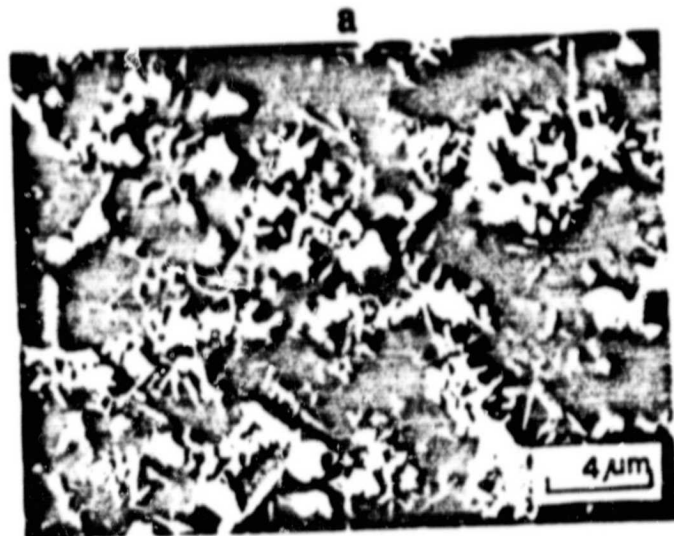
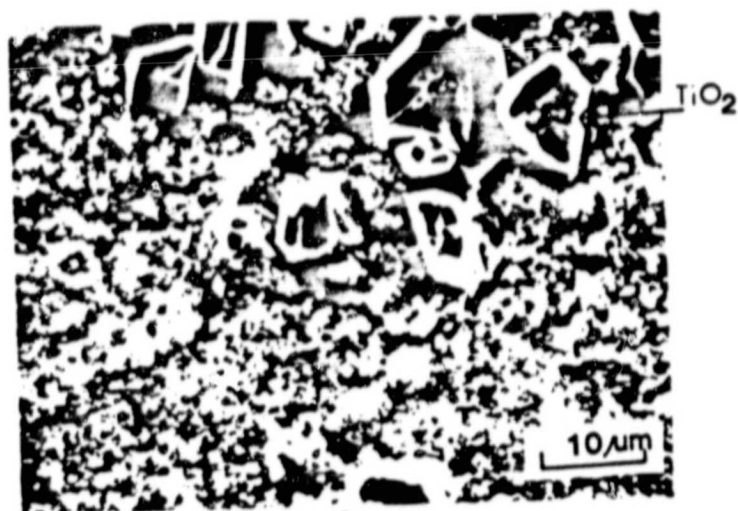
Figure 11. (a) Remelted IN-738 reacted for 10 minutes at 970°C with 1 mg/cm² Na₂SO₄ coating
(b) Another region of the same specimen showing the dissolution of TiO₂

TiO_2 will also be dissolved into the Na_2SO_4 . Figure 11 (a) and (b) show the surface oxide on two areas of a R-738 specimen reacted for 10 minutes at 970°C . The dissolution of TiO_2 is evident. Figure 12 (a) and (b) illustrates the surface of R-738 after reaction under the same conditions for 52 hours. Now most of the Na_2SO_4 has evaporated from the surface. No Al_2O_3 whiskers are found on this surface and a continuous layer of Cr_2O_3 has formed. Some large grains of TiO_2 lie on the top of this layer. Cross sections of the above specimens are also included in Figure 13 and Figure 14. Figure 13 (a) illustrates the alloy oxidized at 970°C for 10 minutes with a Na_2SO_4 coating. It is clear that the salt penetrated through the outer protective scale. More detail of this region is shown in Figure 13 (b) where the attack of the scale by the salt in the initial stage is evident. Figure 13 (c) and (d) illustrate the alloy after reaction for 30 minutes. The protective scale has started to form but some sulfides can be found in the matrix. The alloy is unaffected by the presence of sulfides for a long time. Figure 14 (a) shows that after one hour of reaction a rather protective scale has formed and possibly some salt is isolated at the scale/metal interface. Figure 14 (b) shows more detail at this interface. Figure 14 (c) shows the specimen after 10 hours at temperature. In some local regions the needle-like internal oxide Al_2O_3 particles have become continuous and incorporated into the outer scale. Extensive sulfidation occurs in this region. More detail of this region is shown in Figure 14 (d) and the corresponding EDAX results from this region indicate a high content of Mo, Ta, W and S as well as Ti, Cr and Al are present at the scale/metal interface. However the weight change of the specimen is still small indicating the reaction is restricted to a very small area. The overall weight changes of the specimens were not affected by the presence of the sulfides until 50 hours. Figure 15 (a) and (c) show the specimen reacted for 52 hours. The scale has become rather porous at this time and again the incorporation of the internal Al_2O_3 particles into the

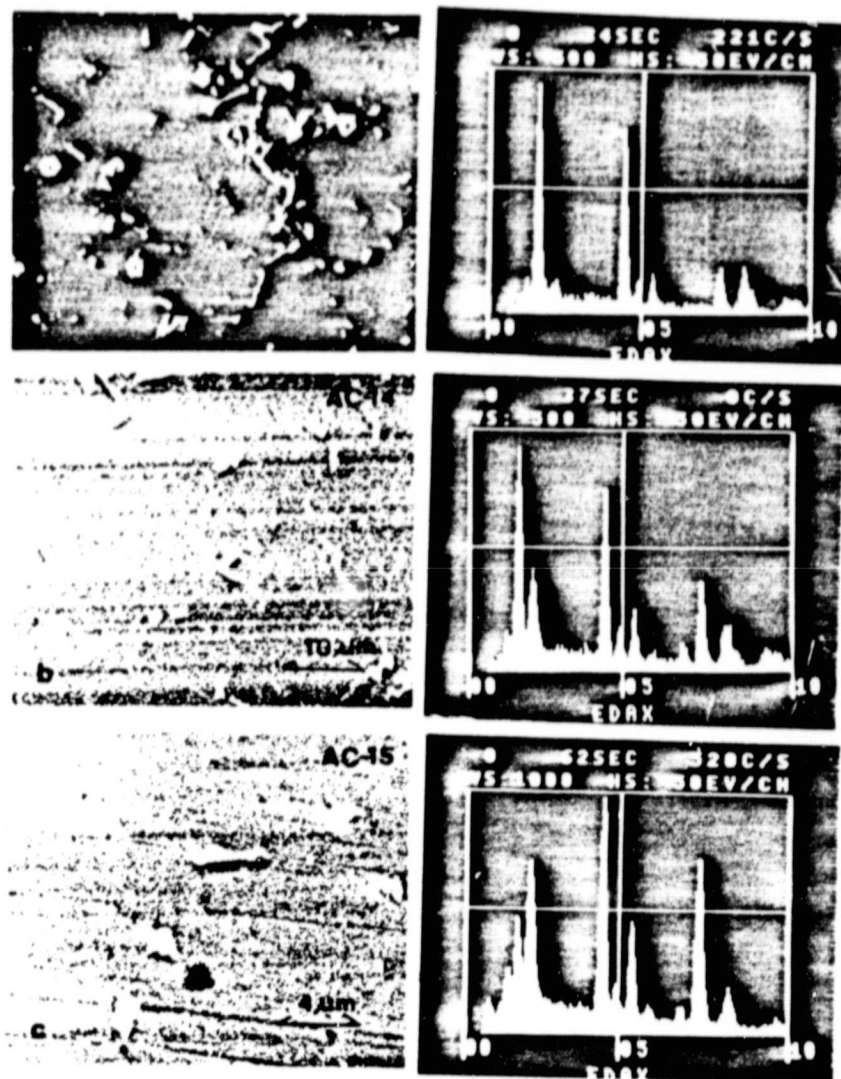
Figure 18. Microstructure and corresponding EDAX Results of the carbides in the alloys:

- (a) AC - 13
- (b) AC - 14
- (c) AC - 15

Their microstructure and corresponding EDAX analysis of the carbides are shown in Figure 18. In AC #13 there is a high concentration of Ta, W and Ti in the carbide. In AC #14 there is a high concentration of Ta, W, Cb, Mo, and Ti in the carbide and in AC #15 there is a high concentration of Ti, Cb, Mo, and W in the carbide. Specimens cut from the as-cast ingots were subjected to hot corrosion with 1 mg/cm^2 Na_2SO_4 and $\text{Na}_2\text{SO}_4 + \text{TiO}_2$ coatings. The reaction curves for these alloys are shown in Figure 19 and Figure 20. It is noteworthy that AC #13 does not undergo severe attack in either case. The major component absent from this alloy is columbium. The columbium in the alloys will preferentially segregate to the carbide during solidification. The role of Cb in promoting hot corrosion attack has been discussed by D. M. Johnson, D.P Whittle and J. Stringer ⁽²⁾ who found the Na_2SO_4 coatings had caused an acceleration in the oxidation rate of a Co-4Cb alloy similar to that in Co-7.5W and Co-4 Mo alloys. Therefore, they conclude, in addition to tungsten and molybdenum, columbium can promote hot corrosion by an acidic fluxing reaction. Cb_2O_5 has a high affinity for oxide ions, forming double oxides at the alloy/oxide interface, a feature characteristic of hot corrosion. Seybolt ⁽³⁾ found that Cb_2O_5 reacted quite readily with Na_2SO_4 , as did WO_3 and MoO_3 . Therefore, it would be reasonable to assume the addition of Cb_2O_5 into Na_2SO_4 would promote

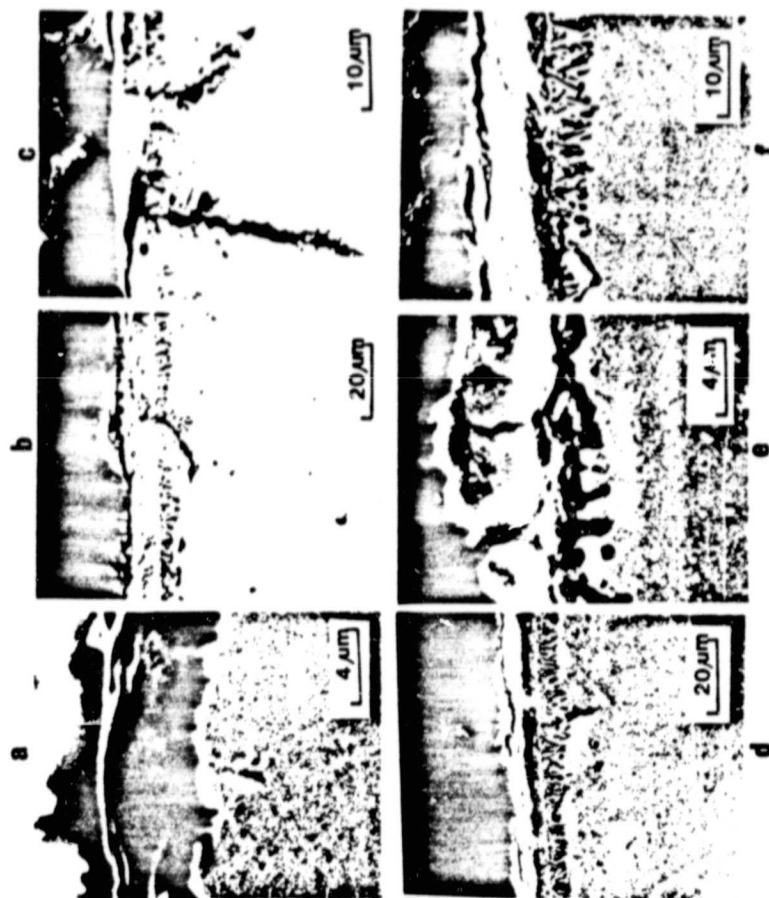
Figure 26. Scales formed in simple oxidation at 970°C on (a) Ni-16Cr-3.4Al-3.4Ti and Ni-16Cr-3.4Al-3.4Ti-x alloys where x is (b) 1.7 Mo, (c) 2.6W, (d) 1.7 Ta, (e) 1.7 Mo+ 2.6W, and (f) 1.7 Mo + 2.6 W + 1.7 Ta
